Suspect/Counterfeit Items Awareness Training

**U.S. Department of Energy
Environment, Safety and Health
Office of Corporate Performance Assessment**

May 2006

Suspect/Counterfeit Items Training

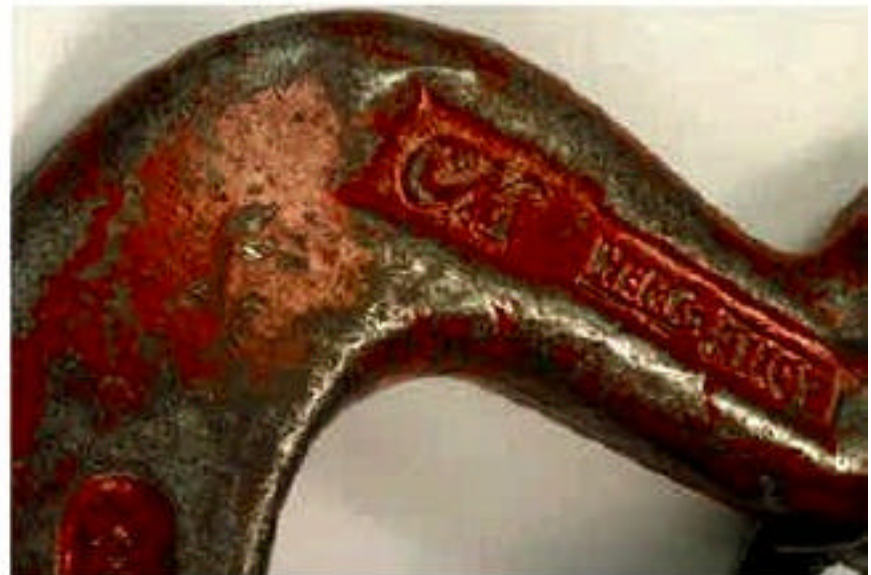
Red color is the Crosby Group, Inc. trademark-patented color
Represented as being new in condition shown above
Appearance very worn

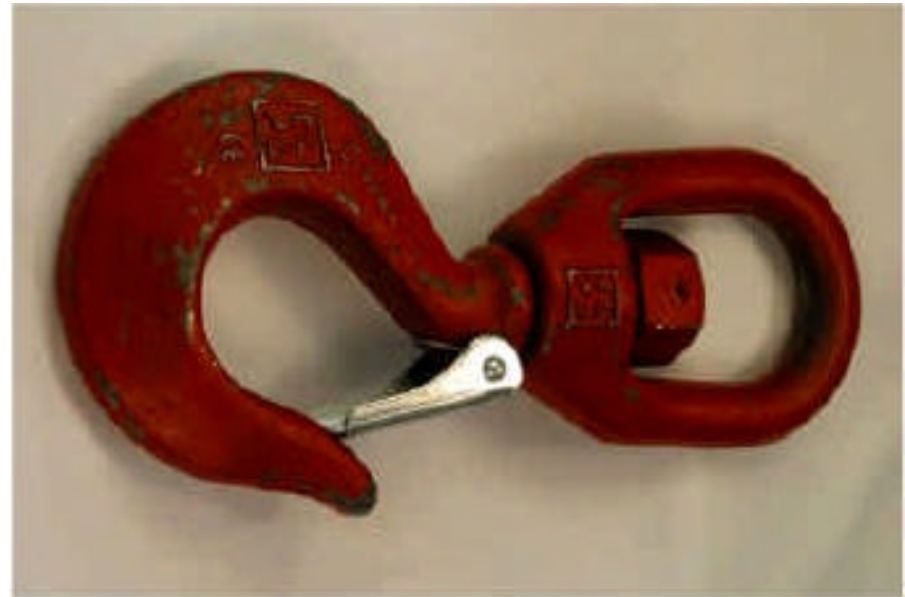
Swivel Hook - Red Counterfeit

Color of hook is RED. Crosby Group, Inc. has the patent, trademark registration for the color RED in the United States

See note on page 45

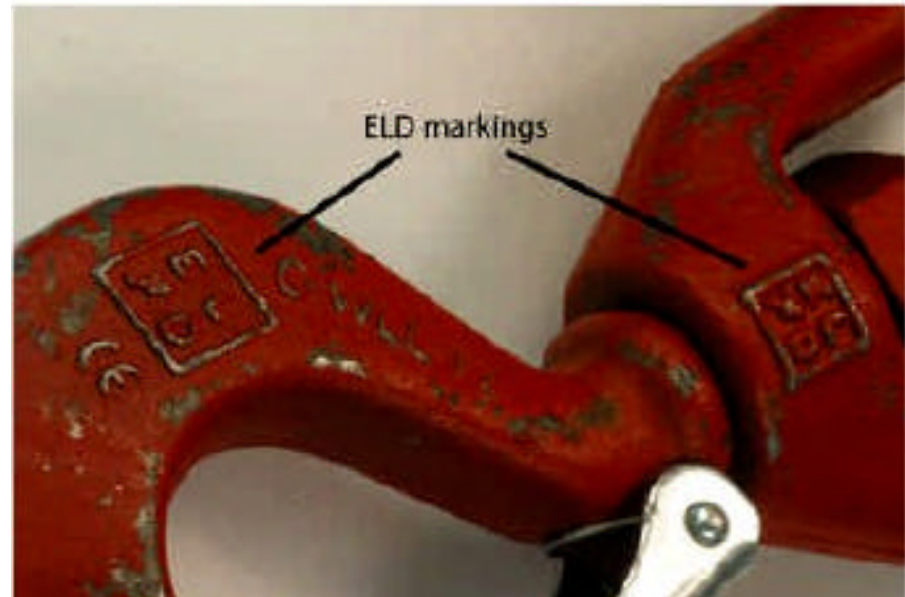
Hook received from Crosby distributor and represented as being Crosby.
Marking on hook "ELD," not "CG" or "Crosby" - Crosby markings

See note on page 45.

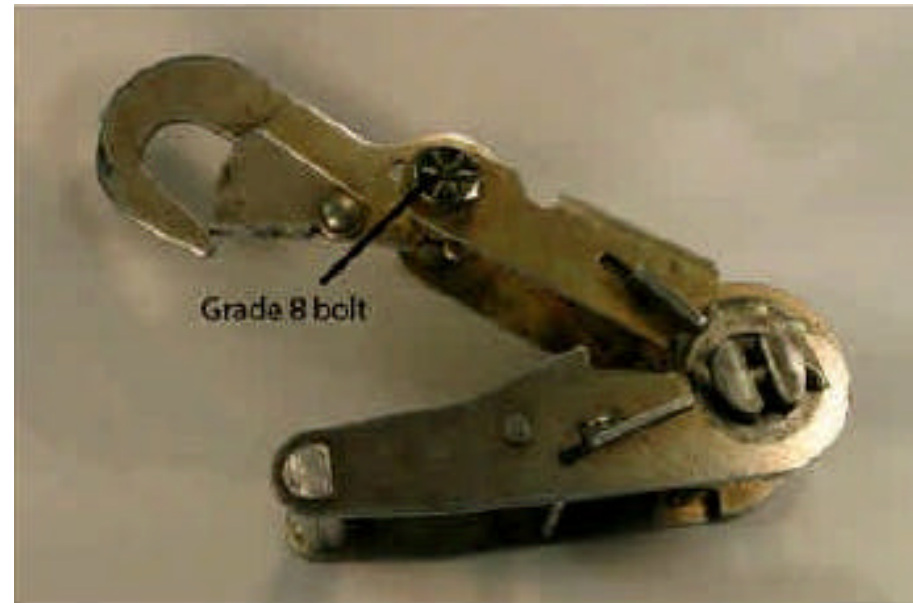
**Ratchet tie-down without strap
Counterfeit**

Bolt in ratchet is a Grade 8 with no manufacturer marking, which is on the DOE Suspect/Counterfeit Headmark list.

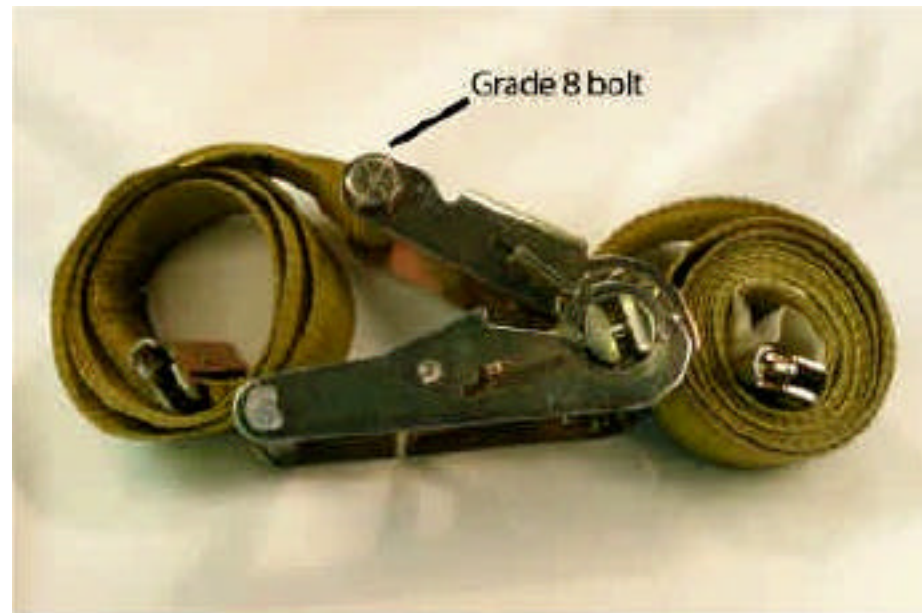
Ratchet Strap Tie-Down Counterfeit

Bolt in ratchet is Grade 8 with a manufacturer marking of “H,” which is on the DOE Suspect/Counterfeit Headmark list.

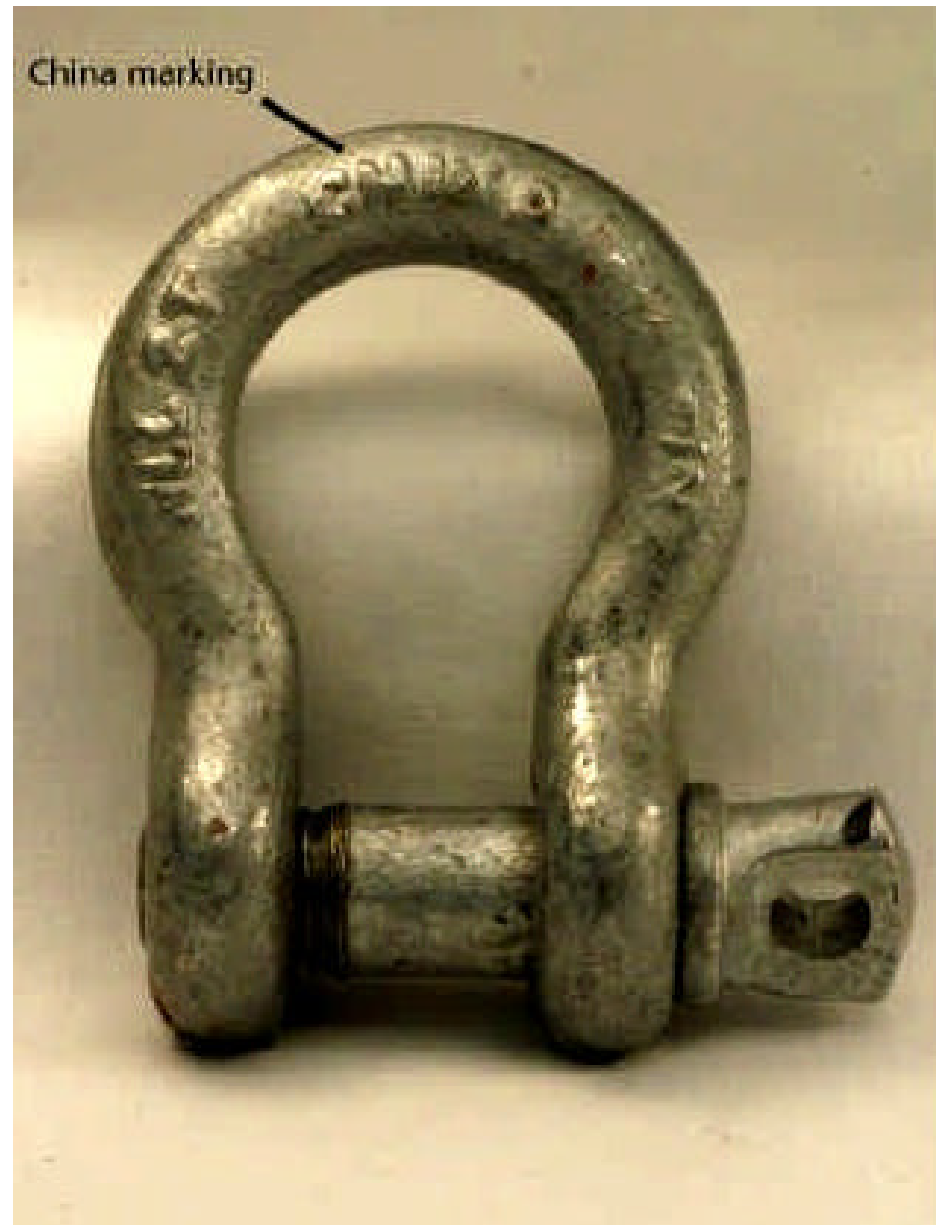
**Shackle
Counterfeit**

No manufacturer markings.

“China” is marked; however, this is unacceptable as standard requires the manufacturer’s name or trademark.

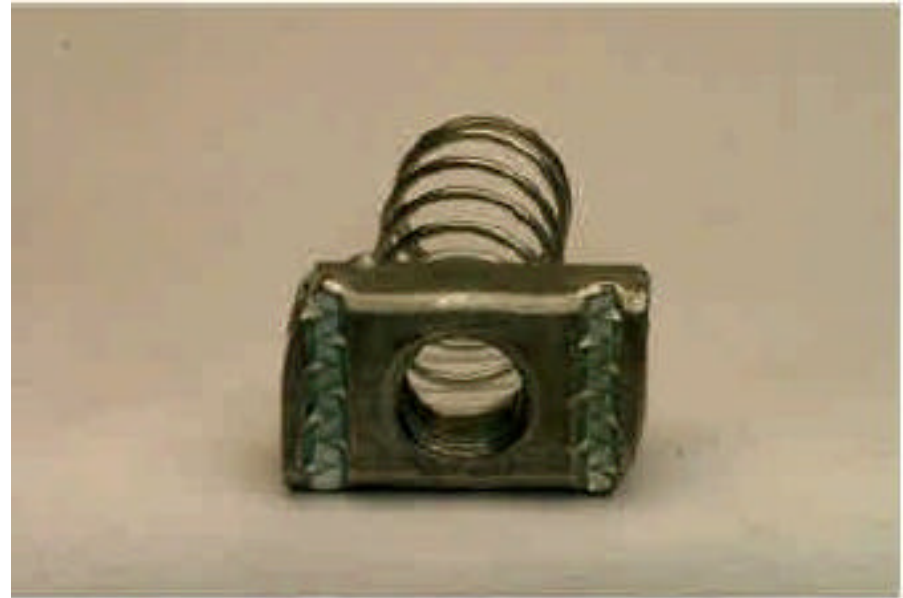
Bottom view

Spring Clip Counterfeit

No manufacturer's name or logo on part
No part numbers or size

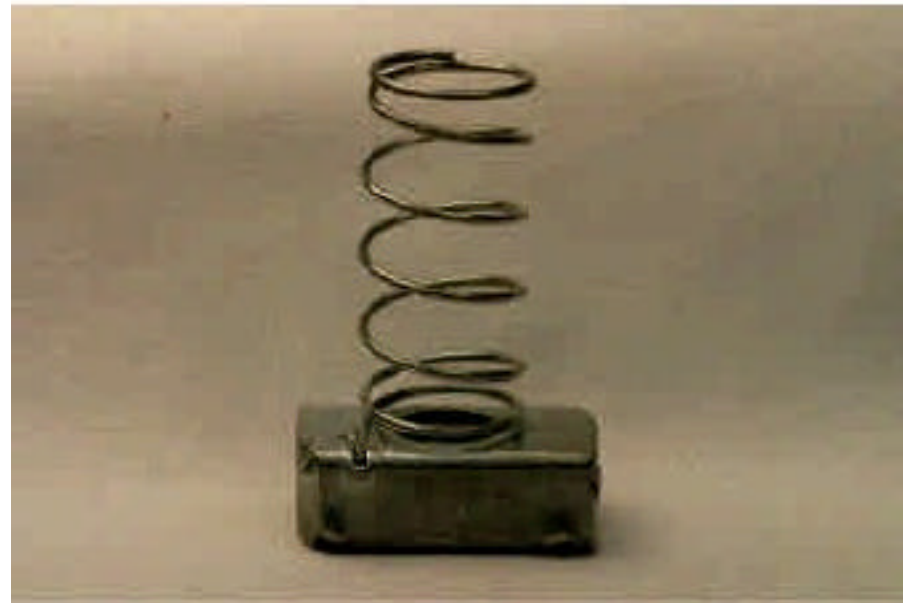
Side view

No manufacturer's name or logo on part
No part numbers or size

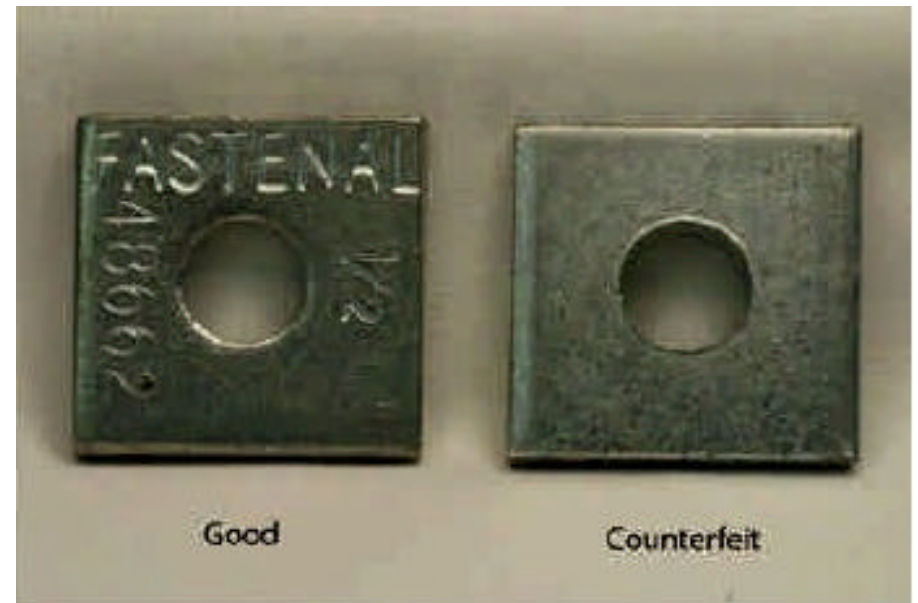
Square Washers/Spacers

Received in the same box together

Left - has proper markings. Good.

Right - has no markings. Unknown manufacturer.

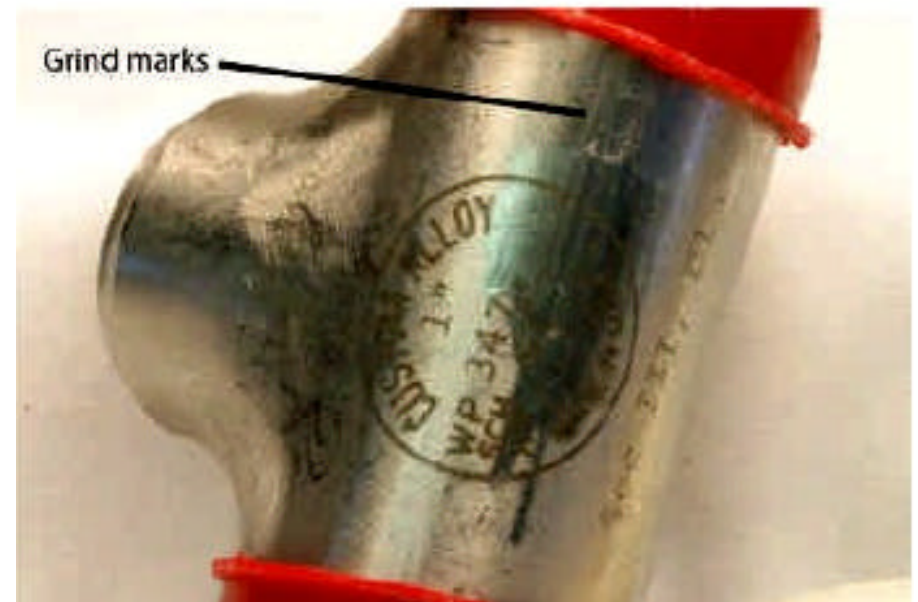
Stainless Steel "T" Weldolet Counterfeit

Grind marks where information was removed
New information stamped on

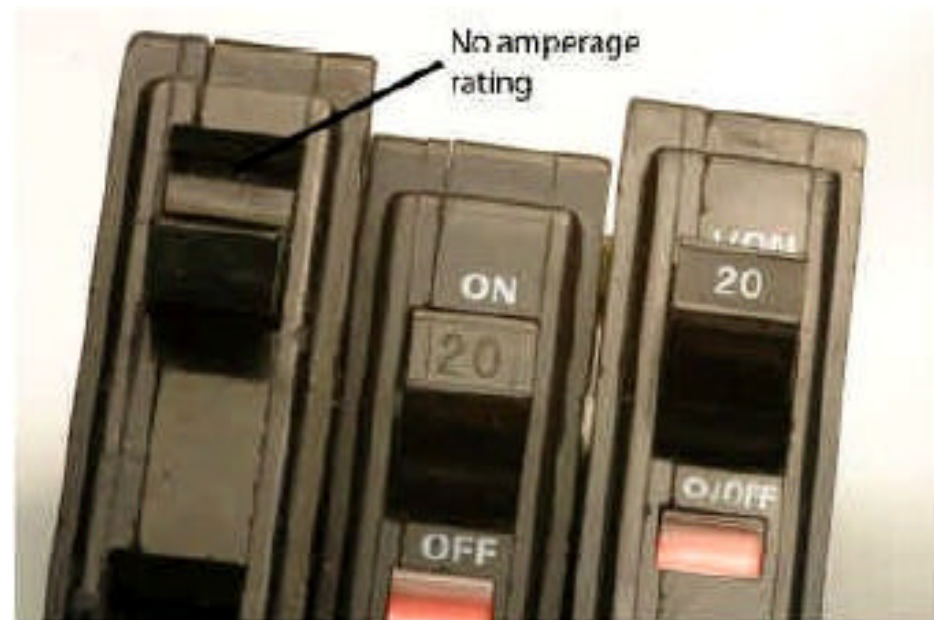
Comparisons of Square D Breakers

Left - Counterfeit

Middle and Right - Good

20-amp rating clearly displayed

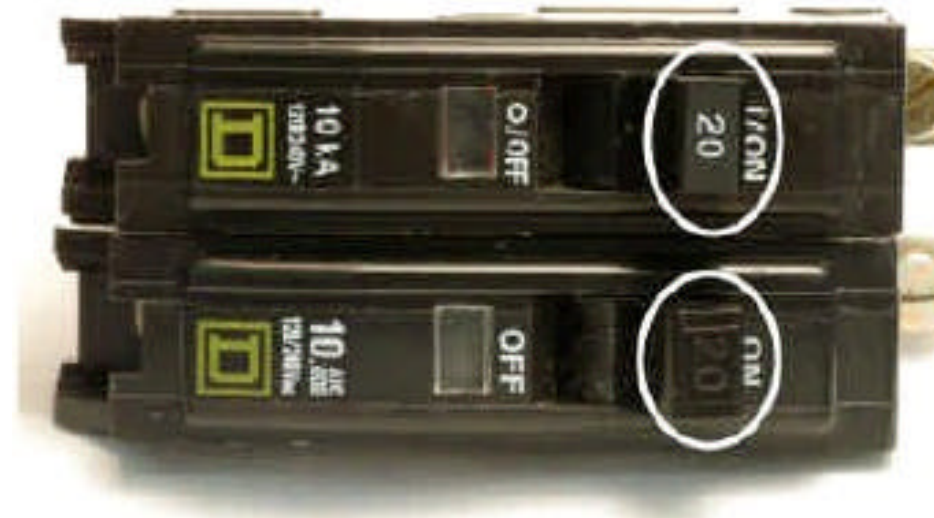
**Square D Breakers
Both Good**

Clearly marked amperage rating on end of switch

(Square D started silk-screen process in 2003)

Rating on bottom switch is molded

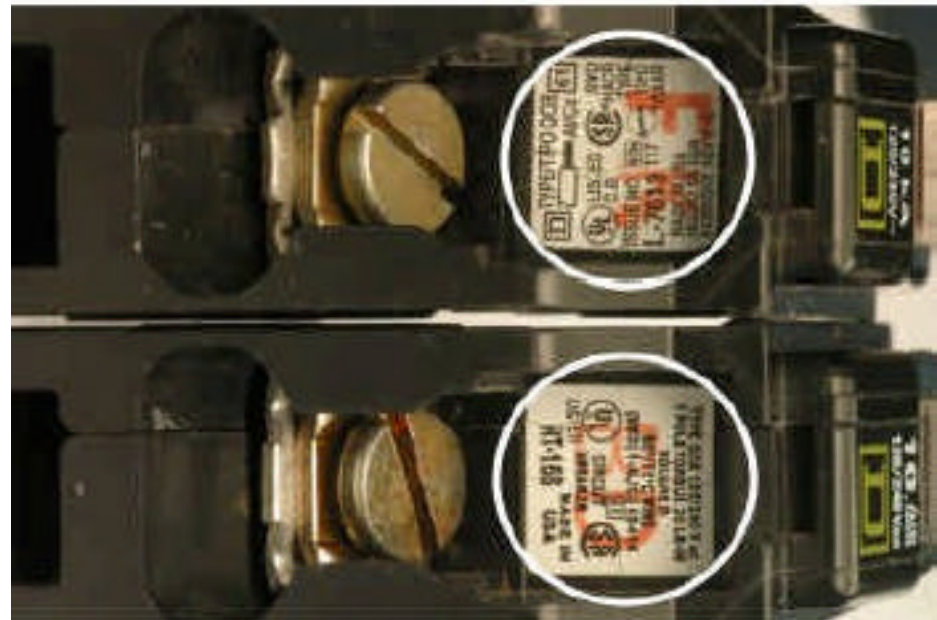
Good Breakers

"UL" label on end of switch (black lettering on white background - two larger pinkish-red letters stamped on label)
Manufacturer can identify date period manufactured from two larger letters

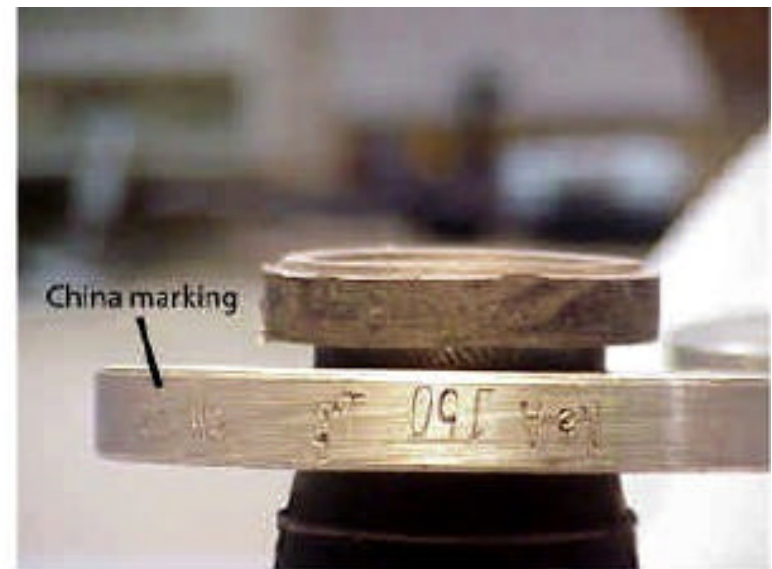
150 lb. rated flange
Should be 0.940" thick - 0.000+0.125
This one is 0.69920" thick.

Apparently hand-stamped
No manufacturer marking. "China" unacceptable as
manufacturer. NO STANDARD MARKING (i.e., B 16.5)
No material type identified.
